Cura Aquarum in Israel

The Water Cascade at Andriake. New Observations and Insights

Dennis Murphy
Melissa Mengel

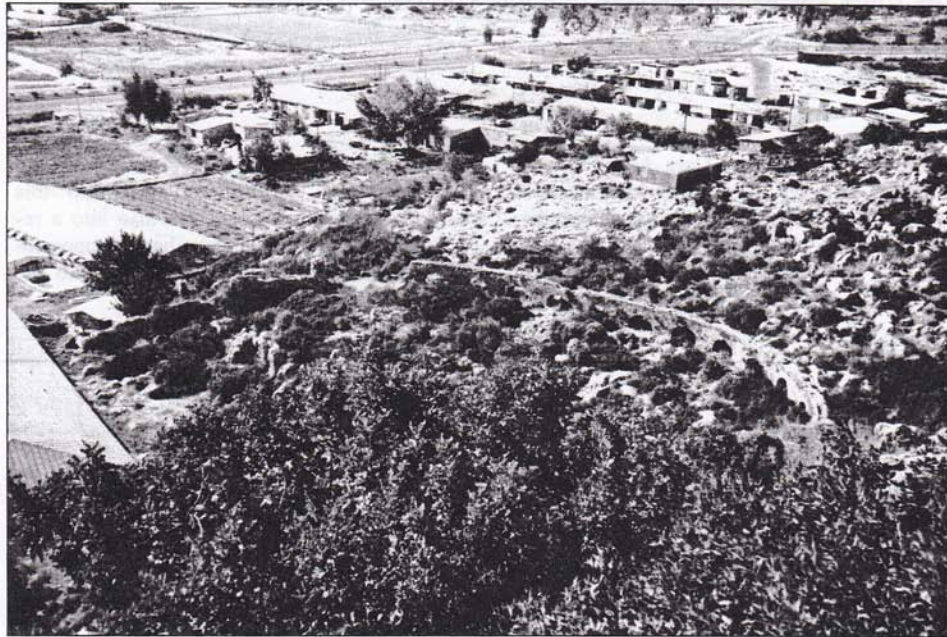
Fig. 2: The Cascade.

Roughly 6 kilometers from Myra the aqueduct makes a sharp turn and drops in elevation from the hillside to the level of the alluvial plain. This was accomplished by the means of a short raised arcade, which ends in a large stone structure made up of levels or steps. Our original research focused on an earlier archaeological survey of Myra, which identified

this stair step structure as a mill complex² (Fig. 2).

At first glance the structure resembles the millraces in the ancient mill complex at Barbegal in France. However, upon closer examination several fundamental elements are found to be missing. There is no evidence of an associated mill house. The adjacent area around the stair step is close to bedrock and no foundations are evident that would have indicated a mill house. Even if a building had been constructed using only timbers, post-holes in the ground nearby and attach points for the building would have been evident in the outer walls of the structure. The size of the individual stair step tanks would not have properly accommodated either an undershot

or overshot water wheel.³ Additionally, if there had been a chute extended out over a water wheel on each level of the structure, the size of the wheel could not have been much larger than 1 meter in diameter making it very inefficient for milling operations. Inspection of the structure showed no signs of mounting points to support a water chute either on the top or the front of each tank. The conclusion then was that the stair step structure was simply an energy dissipation device utilized to accomplish a significant drop in the aqueduct's elevation over a relatively short distance and that it was not a mill complex.⁴

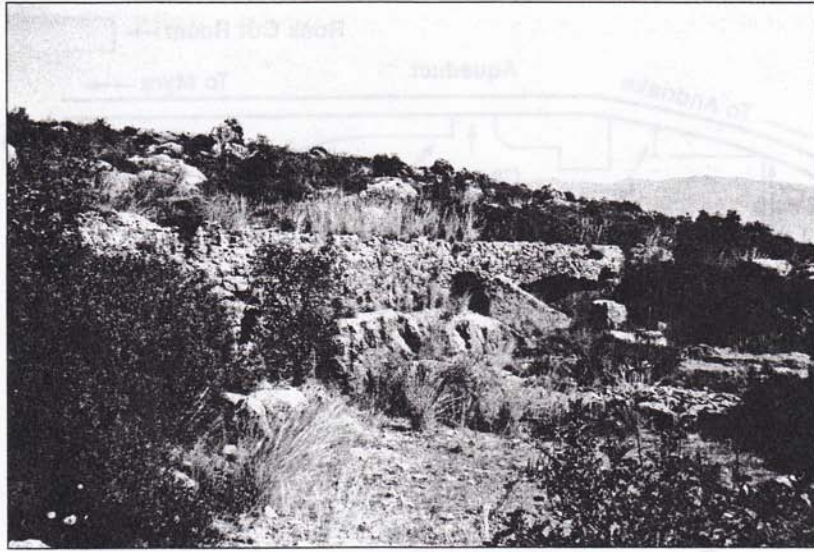
Fig. 6B: Northwest view of retaining pond.
